Instructions for removing the TCU on R230 Chassis

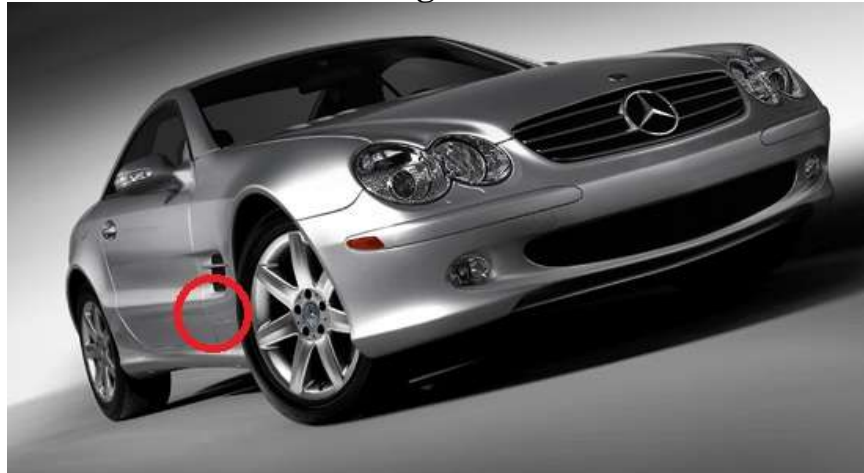
1. Open the passenger-side door of the vehicle
2. Remove plastic screw cover and unscrew panel retention screw

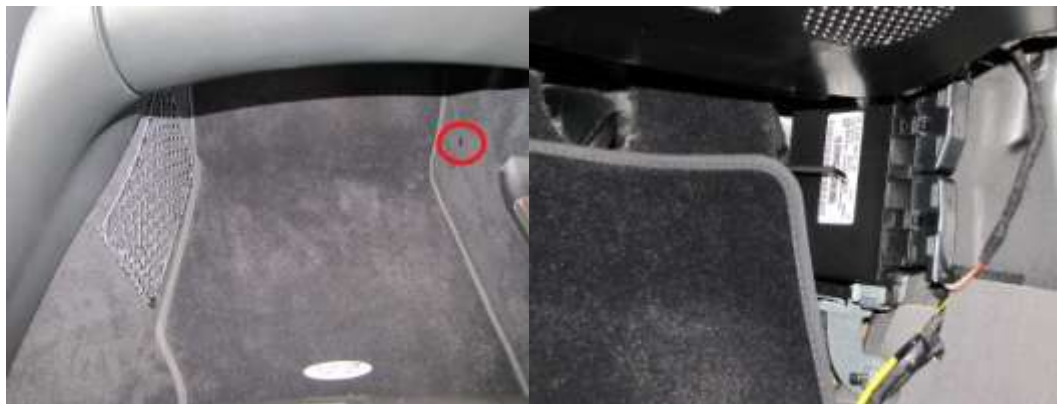
3. Remove side kick-panel
4. Remove TCU connectors (2)
5. Remove the TCU
